## COMPREHENSIVE VEHICLE CONDITION REPORT

VIN	WP0AD2A97GS166080
Year	2016
Make	PORSCHE
Model	911 CARRERA 4 / CARRERA 4S TUR
Mileage	10,572

ID#	1565813492716
Date	8/14/2019
Technician	Dylan S.

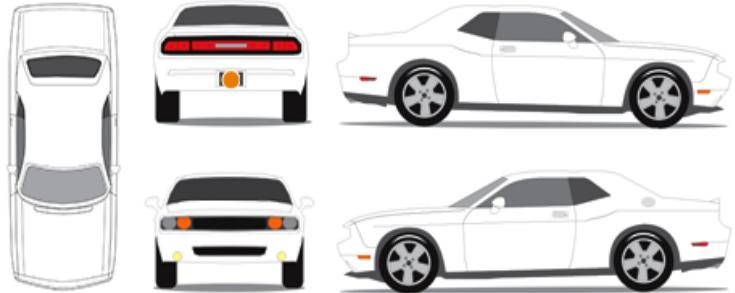
The highlighted points on this vehicle diagram indicate the general areas where our inspection found prior repairs. These issues are not structural in nature and are considered to be purely cosmetic.

Front Bumper Cover	Original
Hood	Original
Left Fender	Original
Left Front Door	Original
Left Rear Door	Not Applicable
Left Cosmetic Rocker	Original
Left Cab Corner	Not Applicable
Left Quarter Panel	Original
Left Bedside	Not Applicable
Roof	Original
Left Roof Rail	Original
Right Roof Rail	Original
Rear Bumper Cover	Refinished
Decklid/Liftgate/Tailgate	Original
Right Fender	Original
Right Front Door	Original
Right Rear Door	Not Applicable
Right Cosmetic Rocker	Original
Right Cab Corner	Not Applicable
Right Quarter Panel	Original
Right Bedside	Not Applicable
Cladding/Mirror Housing	Original

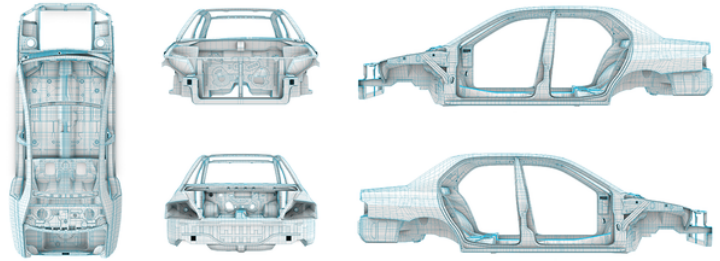
### Engine Bay Underhood (Structural)

Meets True360 Structural Standards
Core Support	✓
Left Strut Tower/Apron	✓
Right Strut Tower/Apron	✓
Cowl Panel/Firewall	✓
Front Left Frame Rail	✓
Front Right Frame Rail	✓
Front Cross Member	✓
